**82541PI**  
***Gigabit Ethernet Controller***  
***Specification Update***

***November 19, 2009***

82541PI Gigabit Ethernet controller may contain design defects or errors known as errata that may cause the product to deviate from published specifications. Current characterized errata are documented in this Specification Update.

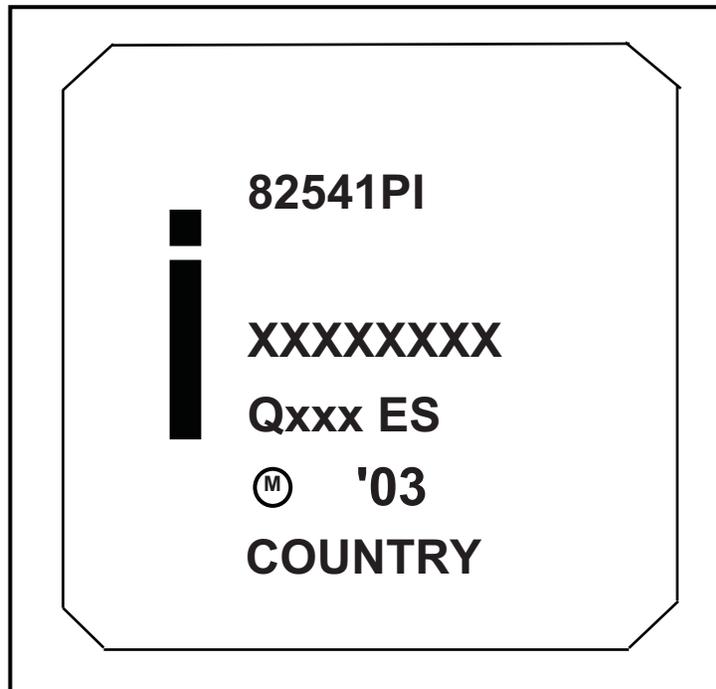
Product	Stepping	QDF Number	Top Marking	Notes
82541PI	C0		541PI	Production Units

**Note:** 82541PI devices that are lead-free are marked with a circled “e1” and have a product code prefix: LUxxxxxx.
